Quantum Software V. 205 Resistor Removal

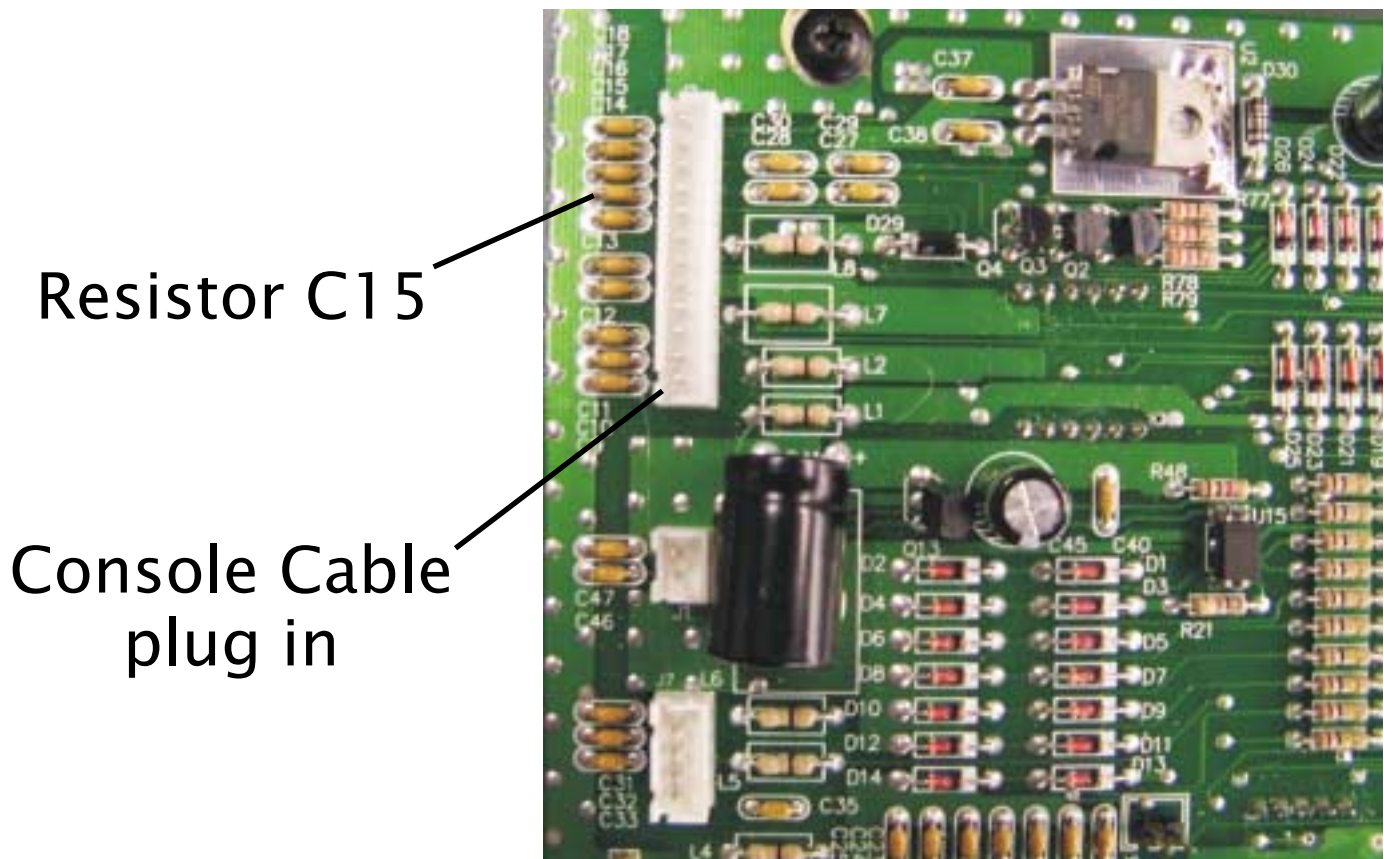
2. Once it is determined that the upper board contains software version 205, verify the value in the Time display window. If the value is approximately 400 to 410, no further action needs to be taken and there should not be any compatibility problems. If the value is approximately 200 to 210, resistor C15 will need to be removed from the upper board. Please refer to the attached diagram to locate the position of resistor C15. Once resistor C15 is located, turn off the power to the treadmill. Remove resistor C15 with a small wire cutter. Once the resistor is removed, turn on the power to the treadmill. Press the start button on the treadmill. If the treadmill belt begins to move, the resistor has been successfully removed. If problems persist, please contact the Horizon Fitness Customer Service Department @ 1-800-244-4192.
